FMW INSPECTION REPORT OF

ERIE LACKAWANNA N° 3372

MOTIVE POWER REPAIR DIVISION

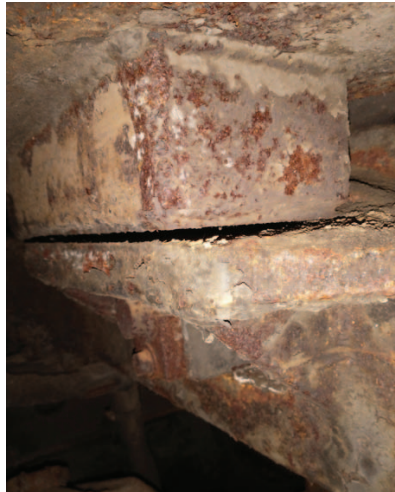
The truck castings appeared sound and no cracks were observed. Side bearing clearance is acceptable. Axles showed minimal lateral play and are well within FRA guidelines.

Side bearing clearance

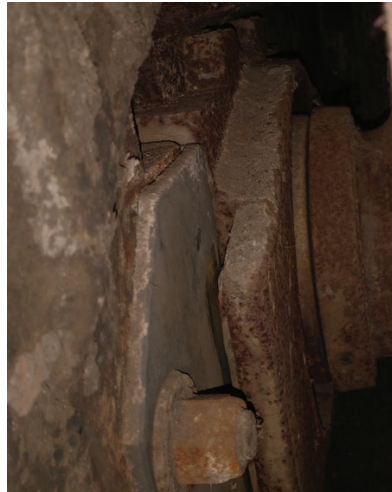
Box lateral in pedestal

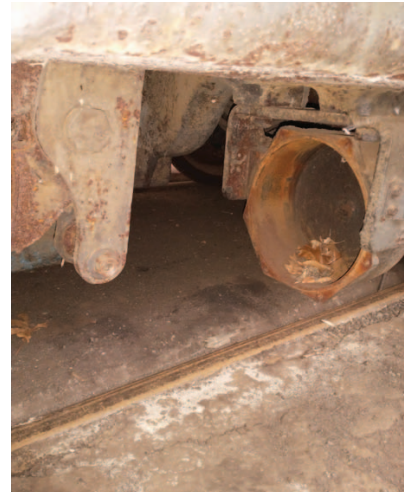
There is enough tread left to re-profile the wheels, but there is not sufficient tread remaining to cut an as-new profile on all wheels. Given the anticipated future use, the wheels will be serviceable for a considerable time with a renewed profile. The front truck is missing a brake cylinder on the fireman’s side, though it is reported to be on the premises. The remaining brake rigging appeared straight and serviceable.

Missing brake cylinder

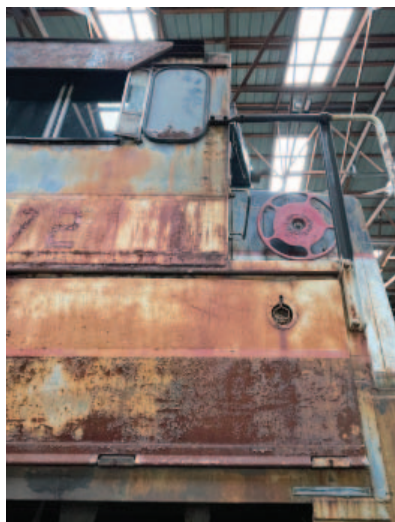
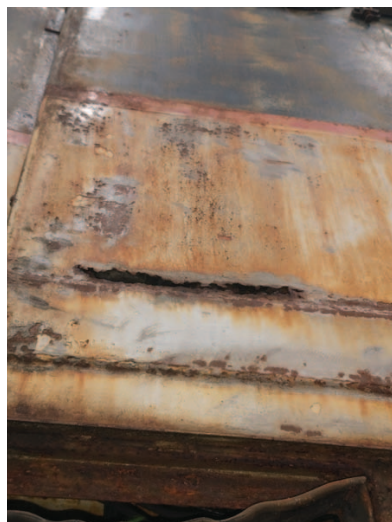
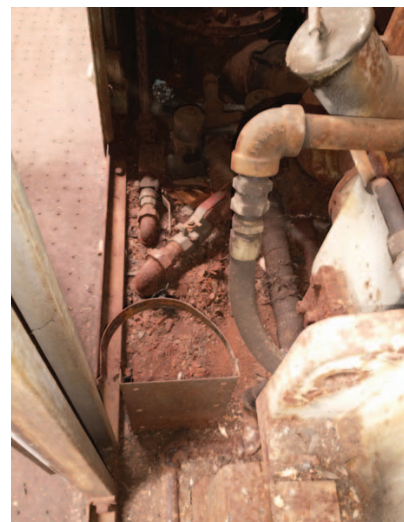
The car body shows signs of surface corrosion and fatigue. There is some perforation on the cab walls and around radiator cooling air inlets but, for a 50-year old GE locomotive, the car body is in remarkably good shape with minimal perforation and surface rust. The car body appears to be straight with no major crash damage evident. That said, the paint is beyond its service life.

The cab is spartan, and it shows little sign of abuse or corrosion and appears complete. Several pieces of glazing are cracked and will need to be replaced.

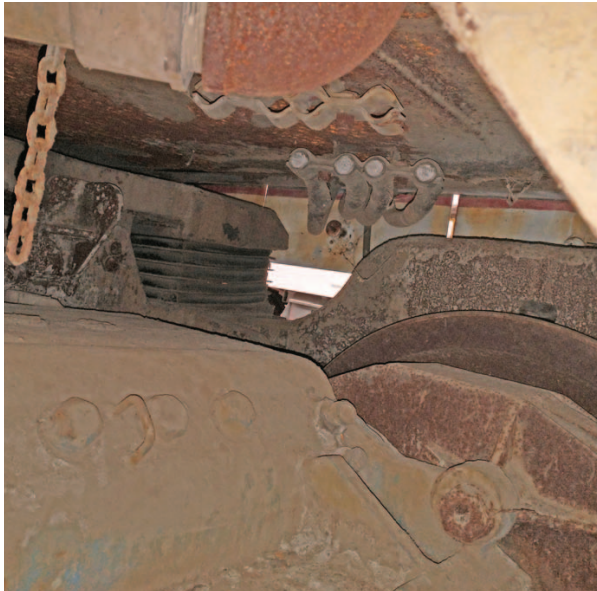
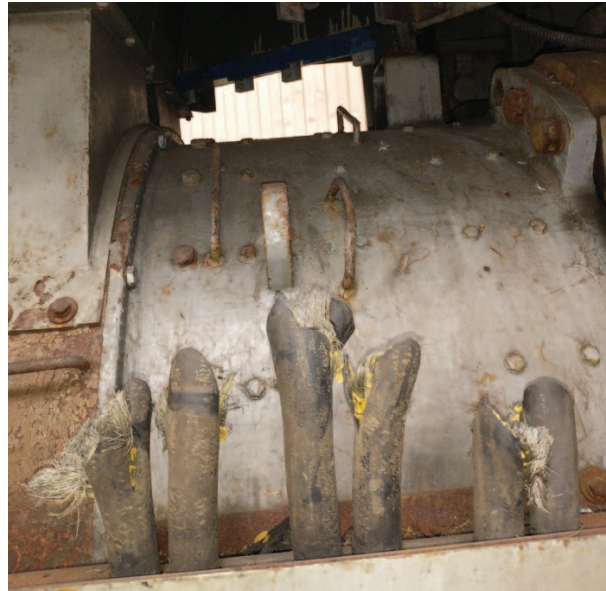
The high voltage system has been vandalized, with multiple pieces of its aluminum cable having been stolen. Traction motors 1, 3, 4, 5, and 6 have had the leads cut [SEE BELOW]. Vandals also removed cable and lugs from the locomotive frame in several spots necessitating new lugs and cable on the locomotive side in addition to the traction motor cable repair. Further, cable and bus bar/components were removed at the main alternator and the diode/rectifier assembly.

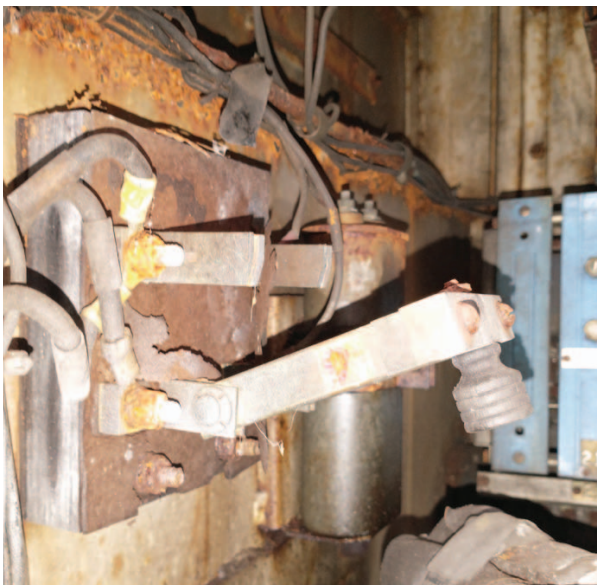
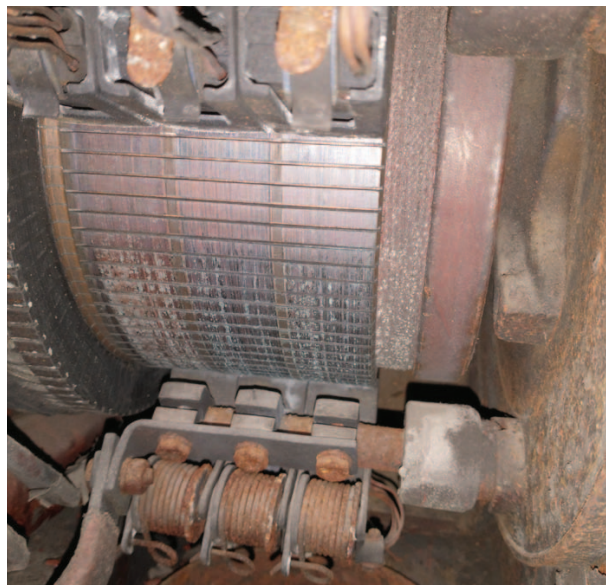
On the positive side, the main alternator was re-wound in 1988, just a few years before the unit was parked, and it exhibits no signs of electrical ground. The alternator slip rings appeared in typical condition. FMW completed ground checks at the reverser high voltage leads and they showed clear, however the ground relay cutout was found to be open. The reverser itself, as well as the power contactors, appeared serviceable, and the exciter commutator is tarnished but usable.

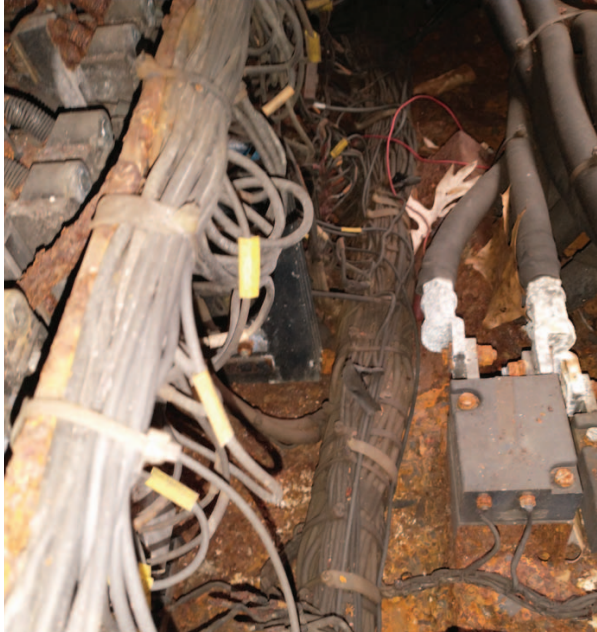
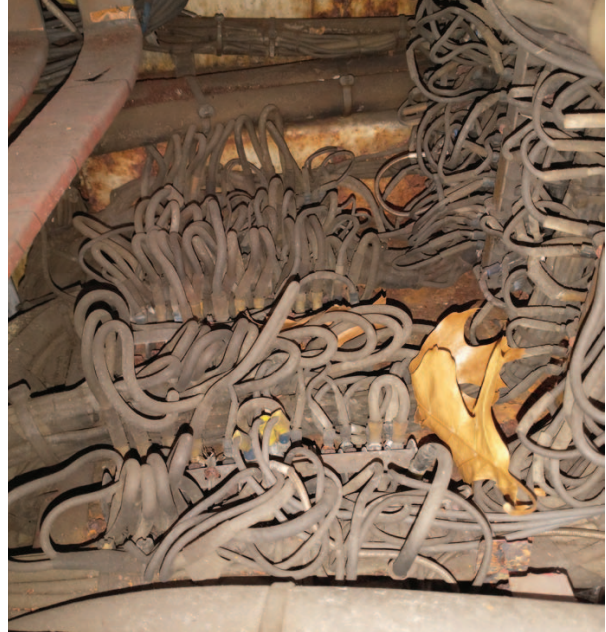
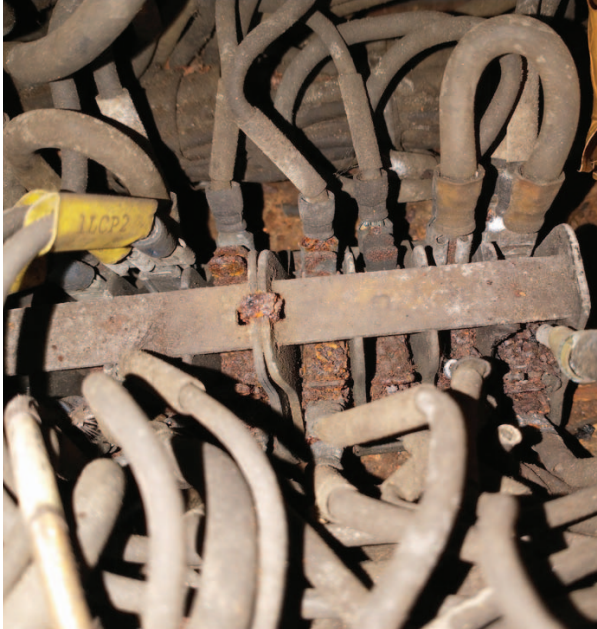
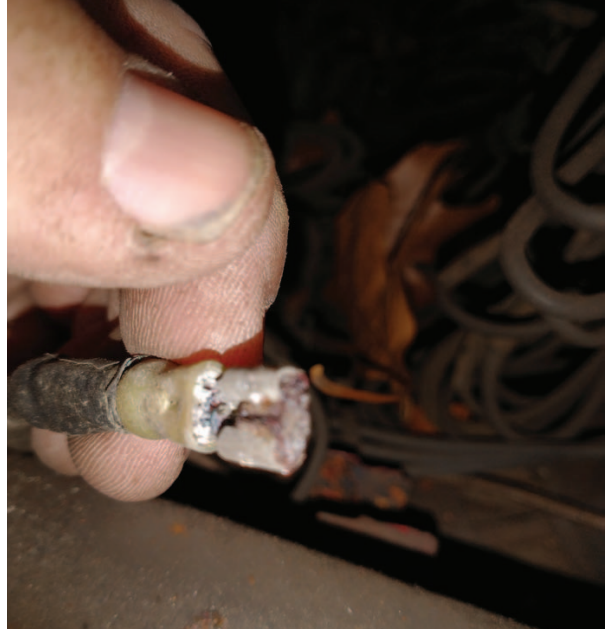
The low voltage half of the electrical cabinet show signs of damage from the aforementioned car body water leaks. While the cabinet is rusted, it has not yet perforated.

Terminals and terminal boards will need replacing before unit can be placed into service. Further, many of the low voltage relays show signs of corrosion and this will surely cause intermittent electrical issues in the future from both sticking contacts and interlocks. Added resistance at wire terminal ends will also be an issue. The photographs above show general condition of the low voltage wiring system.

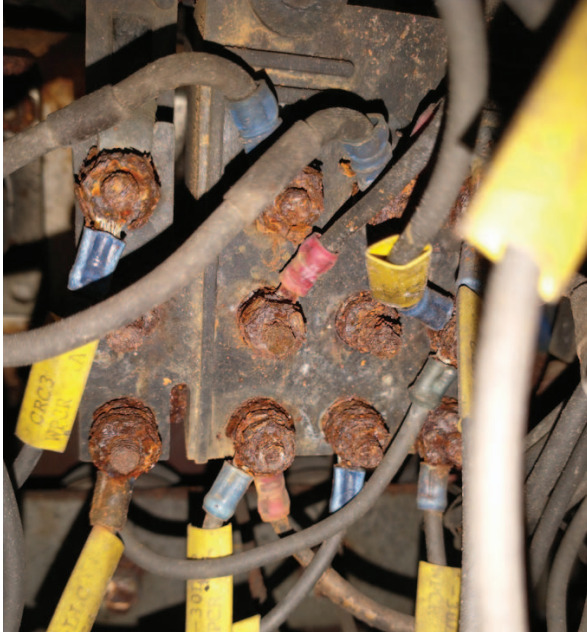
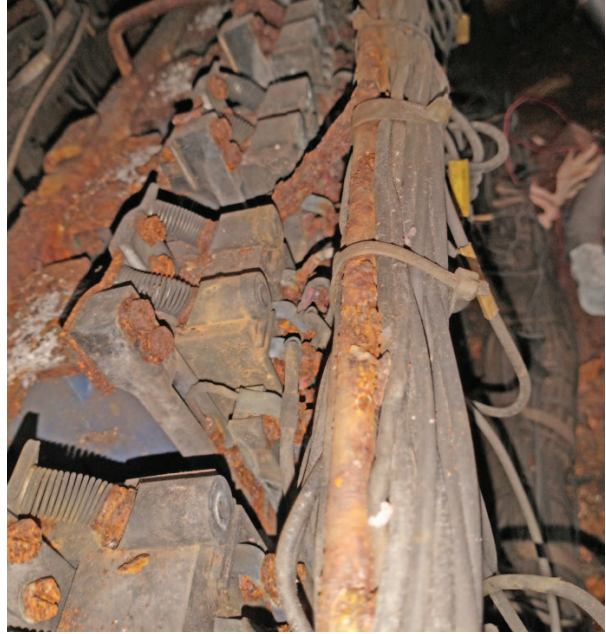
The headlights are missing at the rear of unit. It is anticipated that there will be multiple circuits that will require repair, but No. 3372 does not require a total low voltage rewire. Insulation condition appears quite good, and it is primarily terminal ends, boards, and minor vandal damage that will require repair. Multiple checks on low voltage wiring in the electrical cabinet revealed no grounds.

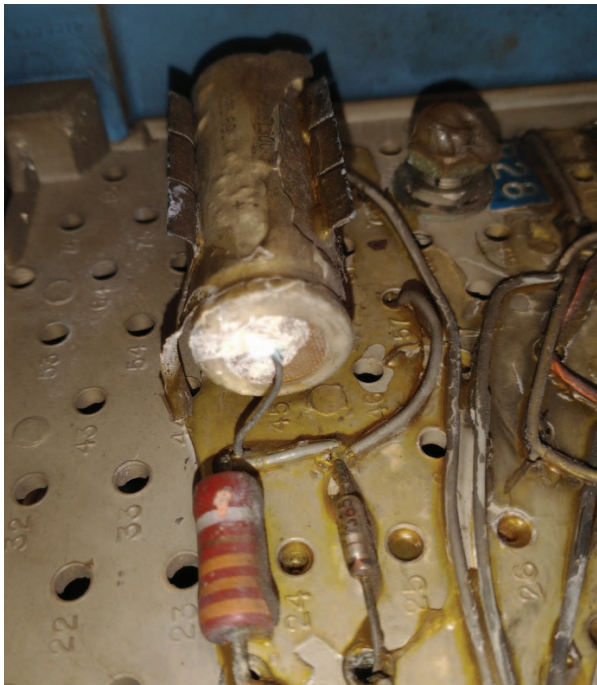
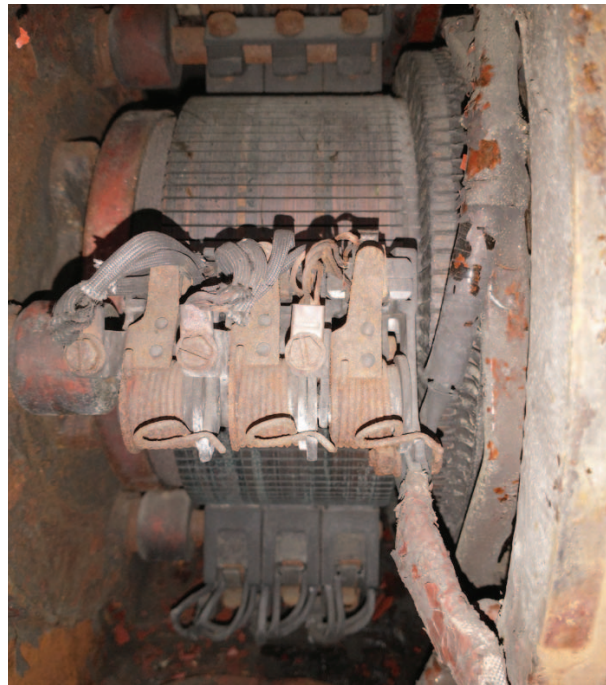
All the panels and GE blue cards appeared present and complete, however we anticipate card damage from age and the high humidity. The aux gen. commutator appeared tarnished but otherwise usable.

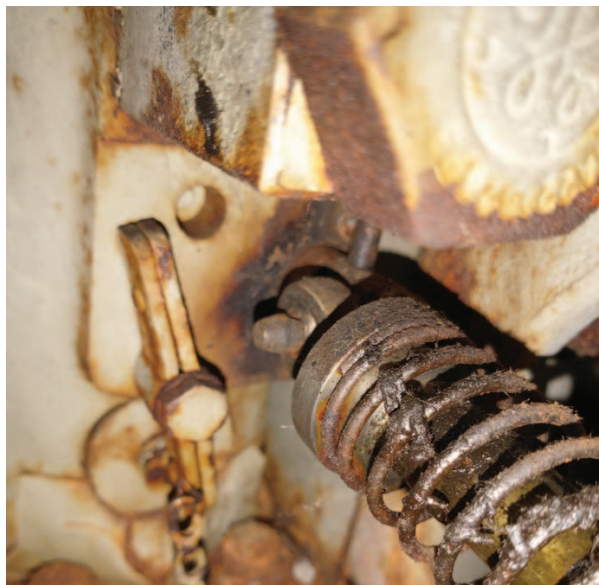
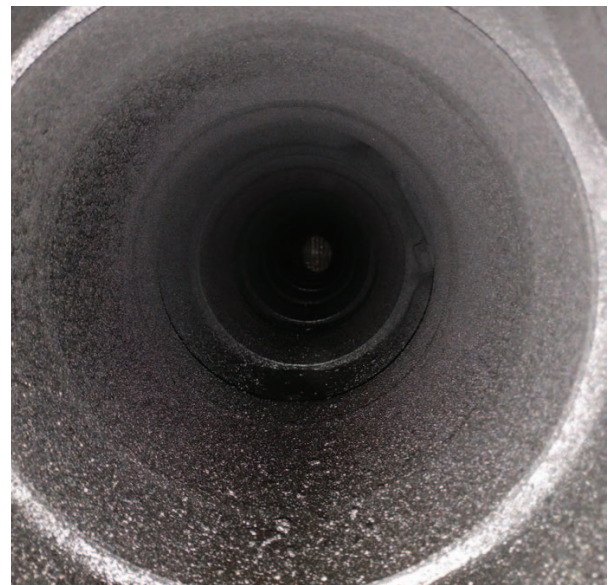
The fuel racks were seized on all but L5, R3, and R7 injection pumps [BELOW LEFT]. The system appeared complete otherwise. The intake manifold was inspected on the engineers side and showed typical minor carbon deposits in the intake ports with minimal oil evident [BELOW RIGHT]. The turbine side of turbo was covered and

- Free up/repair injection pumps.
- Repair/qualify low voltage circuits for: fuel pump, starting circuit, charging circuit, water temperature, oil temperature, and governor circuits
- Check compressor oil
- Lube drive shafts, fan bearings, and angle drive
- Check/service acc case drive oil
- Fill cooling system and repair water leaks
- Replace air, fuel, and oil filters
- Pre-lube and repair oil leaks
- Bar engine over
- Perform close inspection of oil cooler for leaking between coolant and oil
- Adjust valves, check injection timing, set racks
- Install batteries
- Pre-lube again
- Start engine
- Address cam segment/cross heads and other issues as needed.

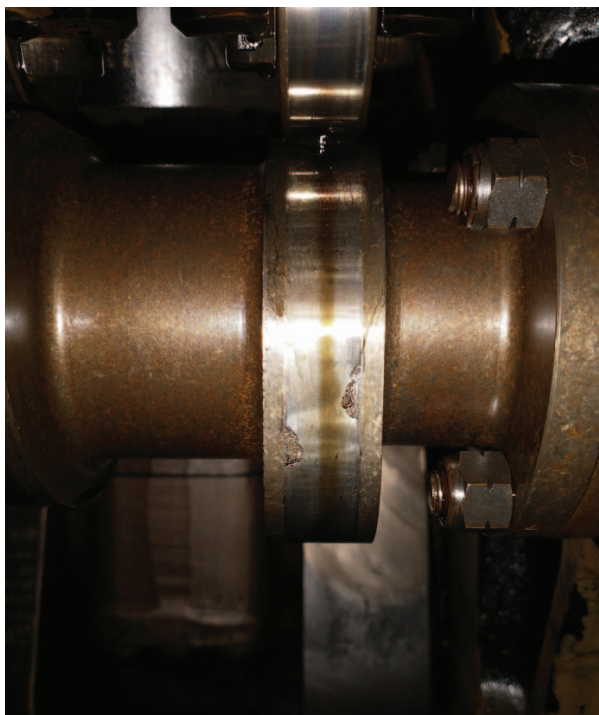
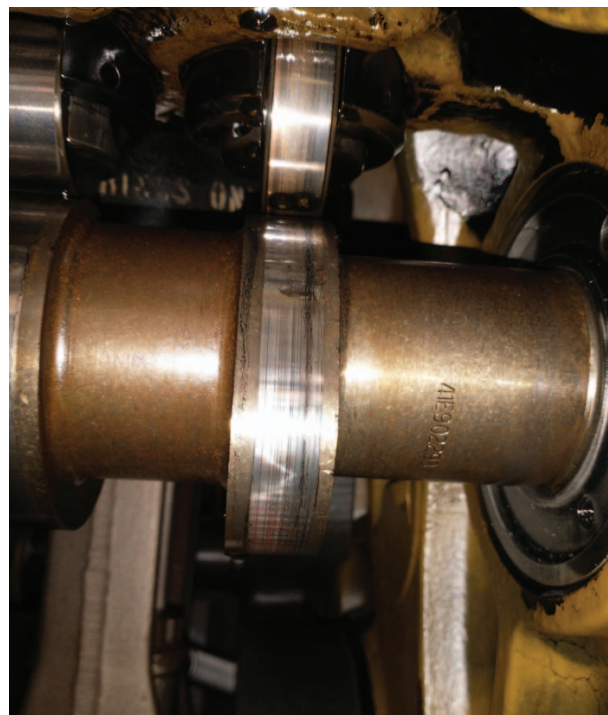
The prime mover had several cam segments spalling with accompanying crosshead issues. This is damage from use, not storage, and it was most likely present/occurred when the unit was still in service with NJT. There were no signs of major oil or water leaks in the car body from last time engine was run. Oil in the sump was at a normal level, and it did not show signs of water contamination.

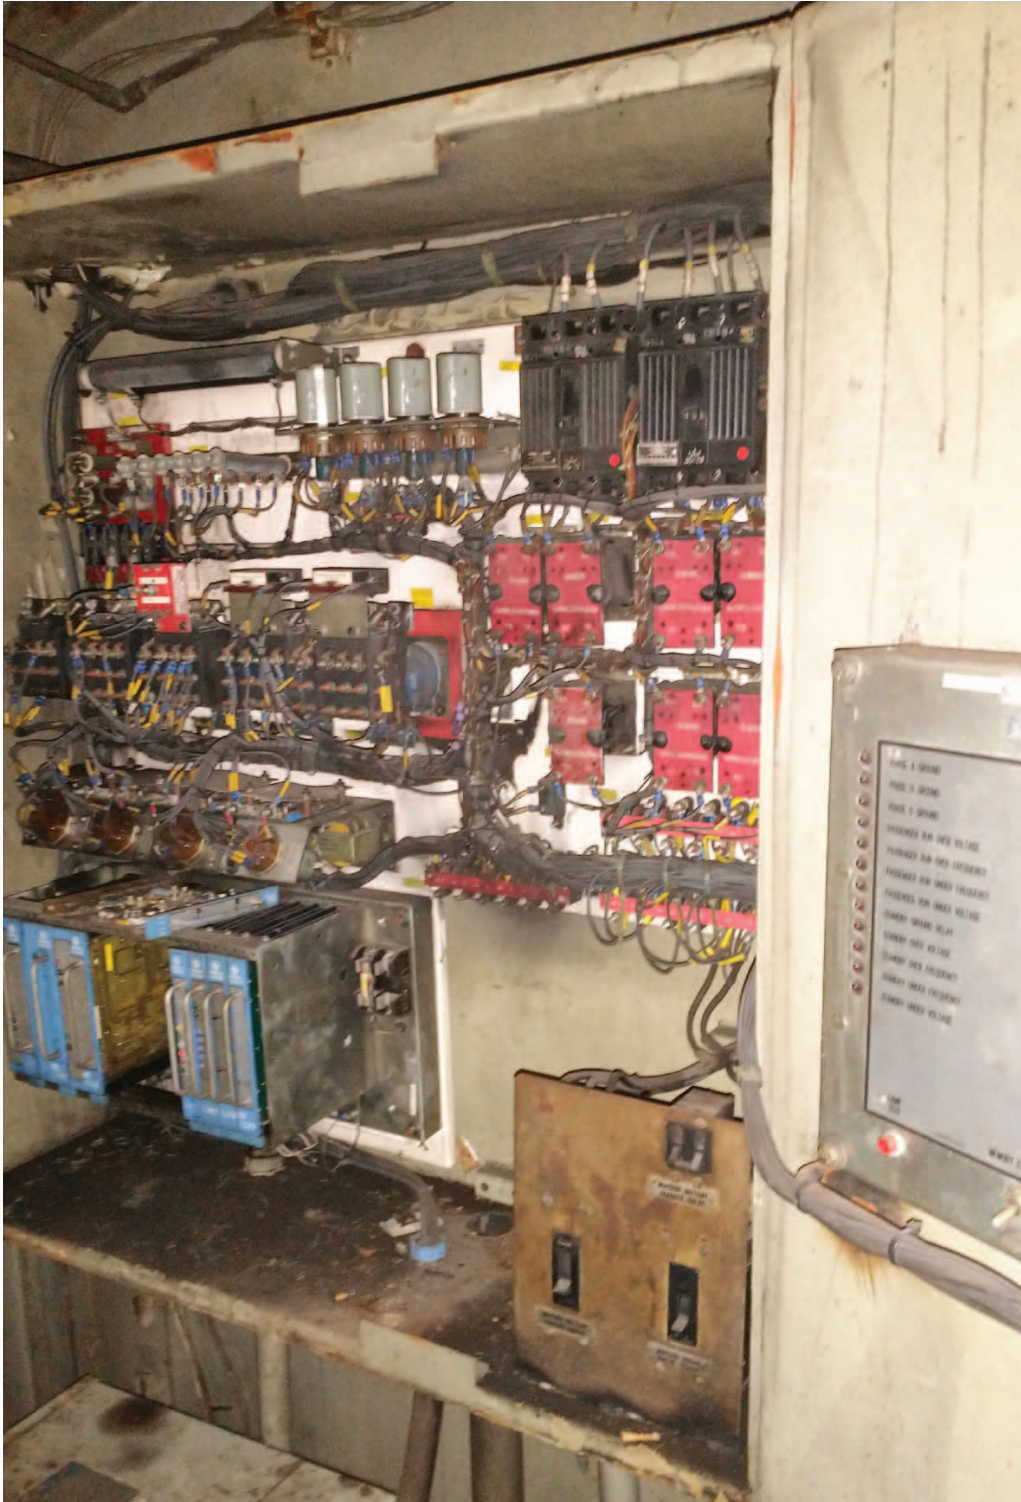
The head-end power system and panels were found to be complete, except for some minor under frame vandal damage. One card in the HEP panel was replaced not soon before unit was retired, indicating potential issues with the regulator.

Phase Four: The HEP system would be returned to service. Detailed scope of work tasks would be finalized as timing and fundraising dictates.
