FMW INSPECTION REPORT OF

ERIE LACKAWANNA N° 3372

MOTIVE POWER REPAIR DIVISION

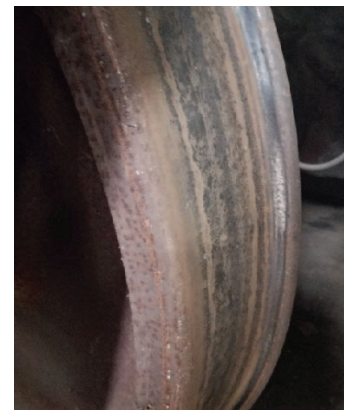
There is enough tread left to re-profile the wheels, but there is not sufficient tread remaining to cut an as-new profile on all wheels. Given the anticipated future use, the wheels will be serviceable for a considerable time with a renewed profile. The front truck is missing a brake cylinder on the fireman’s side, though it is reported to be on the premises. The remaining brake rigging appeared straight and serviceable.

The truck castings appeared sound and no cracks were observed. Side bearing clearance is acceptable. Axles showed minimal lateral play and are well within FRA guidelines.
